Steve Jones 1989 928 S4 Stone Grey Metallic Auto Bizman928@hotmail.co.uk

## **Windscreen Wiper Motor Repair**

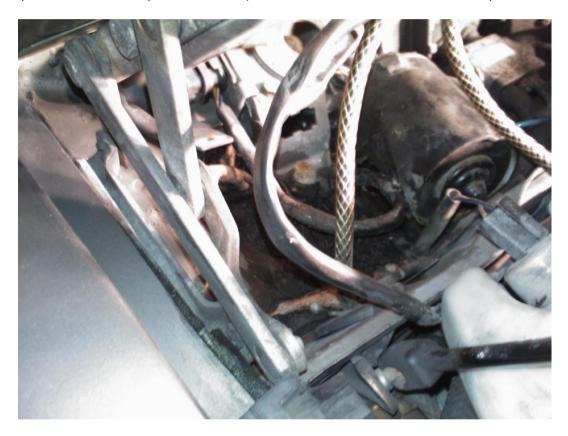
I removed the plastic weather cover above the bulkhead with the bonnet up. This showed the "concentrated washer bottle in the way, so that got its locating bolt unscrewed and then a "slide the right" & "hey presto" off that came — sliding the washer motor out of the centre of the bottle as it came. I removed the but holding the wiper linkage to the shaft of the motor as I wanted to isolate the problem — trapped linkage or seized motor? With the linkage split from the motor, the wipers could move freely but the motor spindle was locked solid! The motor is the problem!

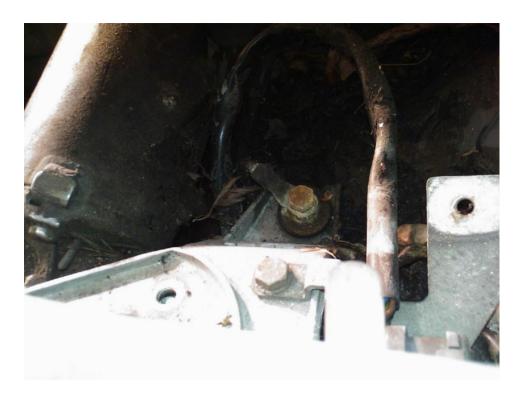
So, to the task of removing the wiper motor from the 928. I removed the wipers, wiper cover trim which bolts across both wipers and across the wings to the small screw at either outer edge under the glass vertical cover strips. All removed & placed carefully on the floor for fear of damage. I then removed the 3 x 10mm bolts holding the motor to the linkage frame and undid the double plug on the left side of the linkage so the motor could be free to remove. The motor was stuck, trapped by the linkage – See the photo. I had to remove the single 10mm bolt at the base of the linkage that also holds the earth wire to the motor to facilitate the motor removal. [See Photo]

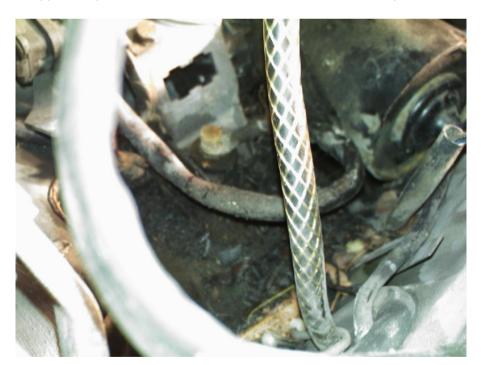
As can be seen in the above photo's, there is some debris, leaves & much under the concentrated washer bottle. This seems to be held on top of the bulkhead by the wires for the wiper motor & others which have sagged or moved with the age of the car & now are sitting on the bulkhead causing a "Dam" effect for anything that may fall in past the plastic weather tray. I took this opportunity to clear all the rubbish in that area and Hoover any residue so the area was spotless.

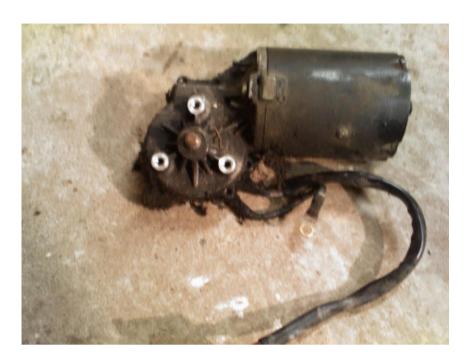
Here is a top view of the motor assembly. [see photo] All outside parts were cleaned and all the debris removed.

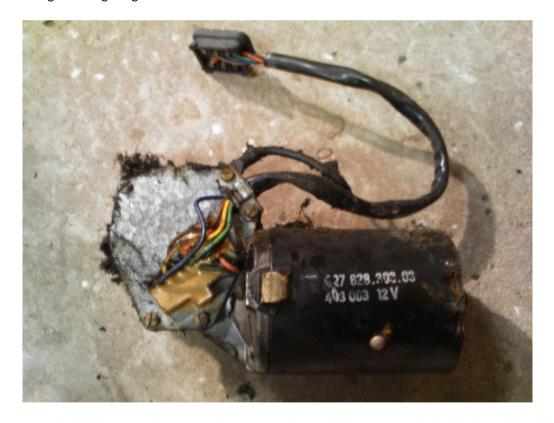
The underside of the motor assembly looks like below. [see photo] I removed the 5 screws and took off the back of the drive housing to reveal the drive mechanism showing the worm drive spindle and concentric circular plastic discs which provide the oscillating motion for the Wiper. These were all nicely still greased up so I left these in situ as they looked like a bitch to put back together & get right.

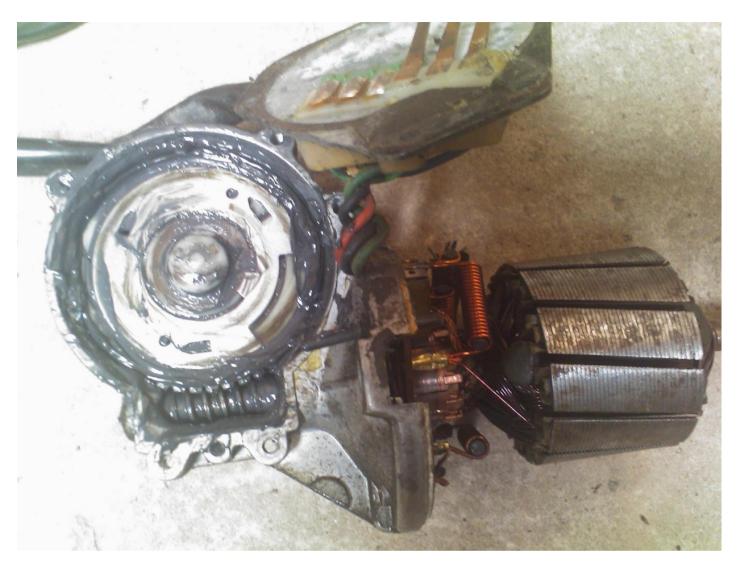
Next, need to remove the field magnet housing. There are two large Phillips screws that hold the Field coil housing to the Alloy cast Drive Mechanism. These need to be removed and the retaining lugs they screw in to, pulled out from either side to allow the housing to be removed. This requires quite a bit of force as the field magnets are strong & hold on to the armature. Once the housing is removed you are left with the stripped motor shown below – [see photo].

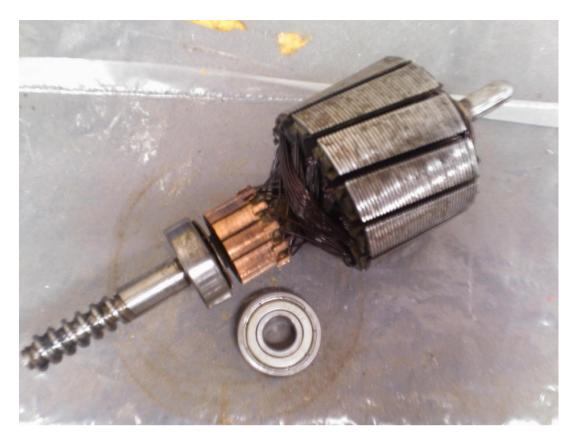
Here you can see the old bearing still on the shaft and the new bearing by the side. This is a very common bearing & very easily available and very cheap at around £3.00. The bearing number is 6000Z

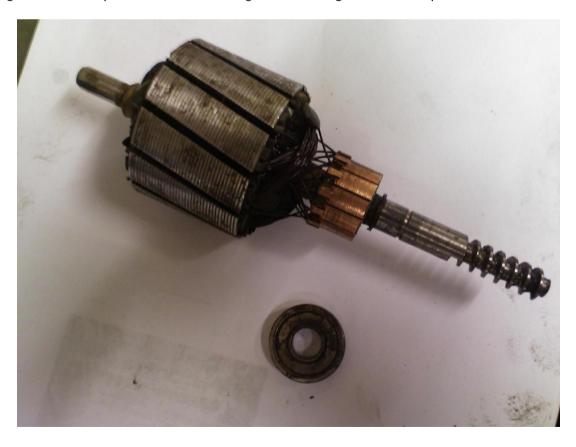
The Bearing now needs to be removed. First remove the circlip from the shaft and get 2 pieces of thin bar which will go in the small 5mm gap in between the bearing and the copper comm. Set these bars across the open jaws of a vice so you can effect a sharp blow with a hammer down on the end of the shaft – being very careful not to damage the end of the spiral worm gear. A few sharp blows & the old bearing is free showing the lower circlip as seen below.

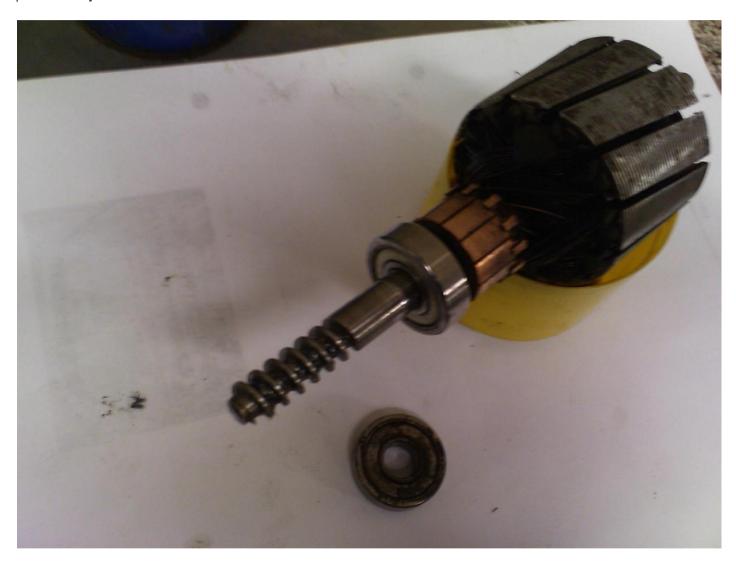
The new bearing is fitted by finding a piece of copper pipe or hard PVC pipe just a bit bigger than the armature spindle diameter but not too large to miss the centre of the new bearing & thus damage the new bearing. Tap firmly in place and refit the 2<sup>nd</sup> circlip on the top of the bearing to hold it in place. New bearing now fitted with old one at the side. [see photo below]

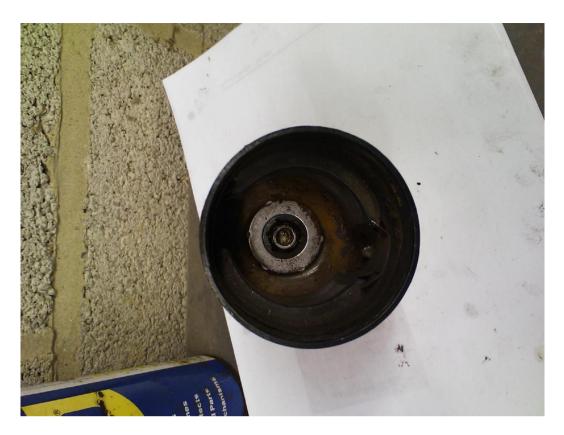
Only thing left to do is clean the inside of the Field magnets & cover. I did this with a flap wheel to make sure there was nothing fouling the gap between the field magnets and the armature. Pay attention to the bearing at the bottom of the cover. [See photo below]

This bearing is a single ball in a clasp. It rotates so once you have cleaned any rubbish from around it you have to make sure it is centred so it will take the shaft at the base of the armature on re-assembly.

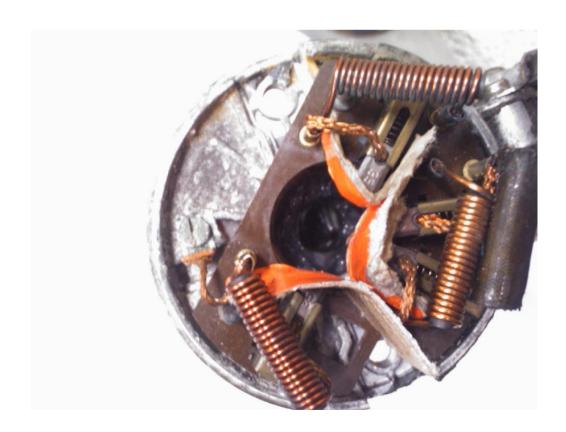
First, cut some thin card strips, about 6mm wide and 40mm long, 3 in all. You will need these to trap the bushes back in their sliding guides to keep their springs & the bushes themselves in place. [See photo]

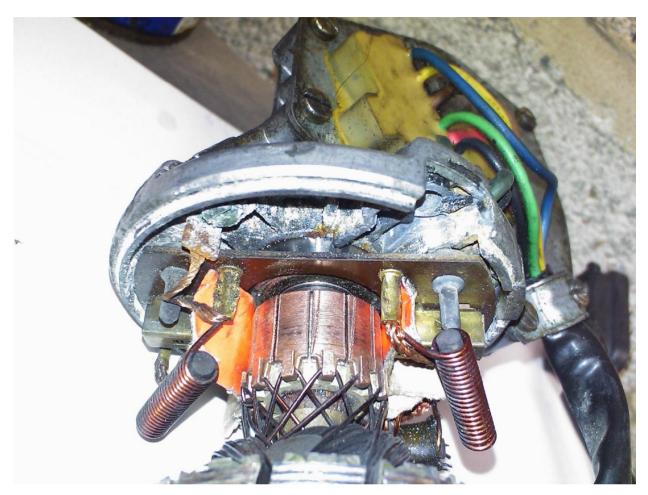
With the cards in place you can then guide the armature back into the drive mechanism assembly until the new bearing is just up to the cards. You will have to turn the armature clockwise as you do this as the worm gear engages with the drive wheels in the housing. Then, Carefully guide the bearing past the carbon brushes pushing the cards outwards to clear the bearing each in turn. Then push the bearing gently into the housing, still rotating clockwise as you go. [See photo below]

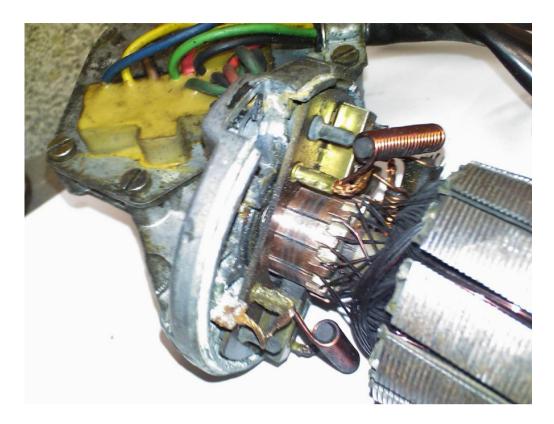
Once the bearing is firmly seated and the worm gear is correctly engaged with the drive mechanism assembly. Rotate the armature shaft to ensure good seating & everything feels ok. Then you can carefully remove the pieces of card which are holding back the 4 carbon brushes. Once removed, rotate the armature again to ensure free running movement & worm drive engages correctly with the drive mechanism. [see photo below]

\*\*Tip\*\*Make sure as you insert the armature & assembly back into the field magnets that you place a suitable screw driver under the casting & all the way to the centre shaft behind the bearing – this is where the locating lugs fit in the to screw the motor housing together – see photo above in 12:00 position - this stops the bearing coming back out & catching the brushes when you place the armature back into the field magnets & housing. The magnets are very strong & "suck/pull" the whole unit in to the housing pulling the armature shaft & bearing back out of the drive linkage housing if you're not careful!

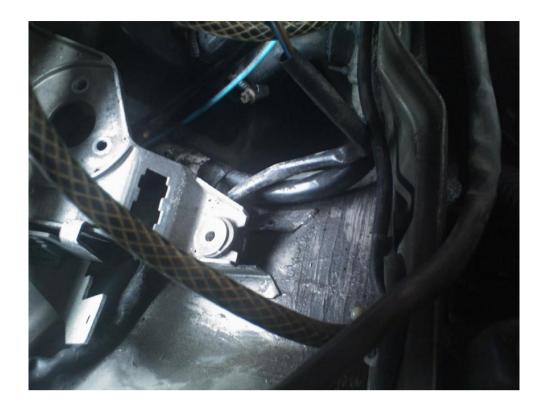
Now the motor is done, make sure you clean all the debris & rubbish that had collected at the top of the bulkhead & under the concentrated washer bottle. Cleaning up the bulkhead around the support bracket for the wiper motor and it can be clearly seen why this problem happens - The large wire going to the Central HIVAC box passes underneath the Wiper Motor and effectively causes a dam for all the debris and water. Potential disaster area! [See Photo below]

Note the position of the wiring harness. This is what causes the rubbish to collect in the first place and fills the area under the motor with water when it rains thus flooding your motor & causing this disaster. Once I re-fitted the motor into the bulkhead I put a cable-tie around the motor housing & positioned the wiring harness so it wasn't resting on the bulkhead floor anymore. Now water can run down into the bulkhead freely should it have to and escape via that ominous little rubber flap that is often talked about on the passenger side of the bulkhead & engine compartment
