## Problems of lubrication of the connecting rod bearings 2/6

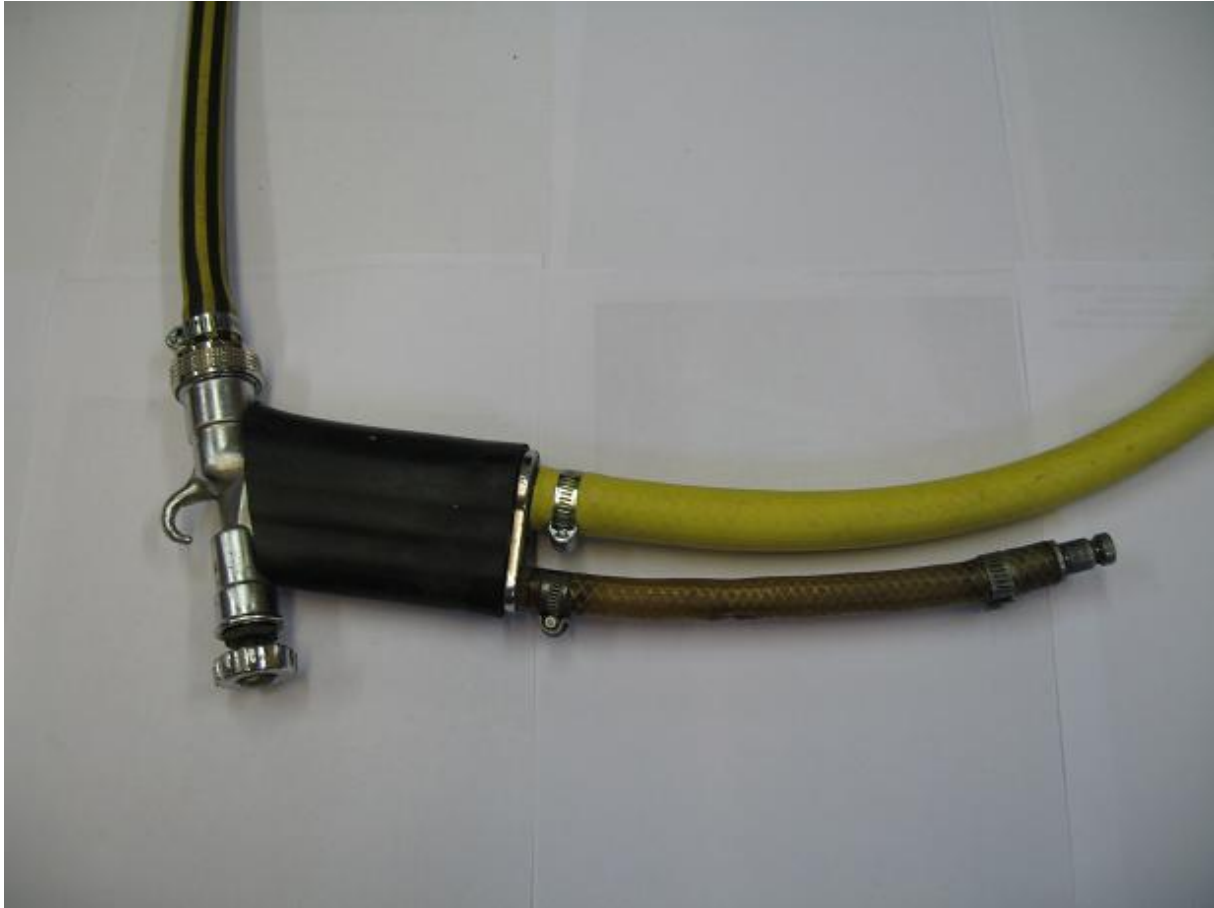
This mixer adds (compressed) air in the liquid to try to reproduce what happens when the oil passages are fed with air-inhaled oil (or foamy oil feeds).

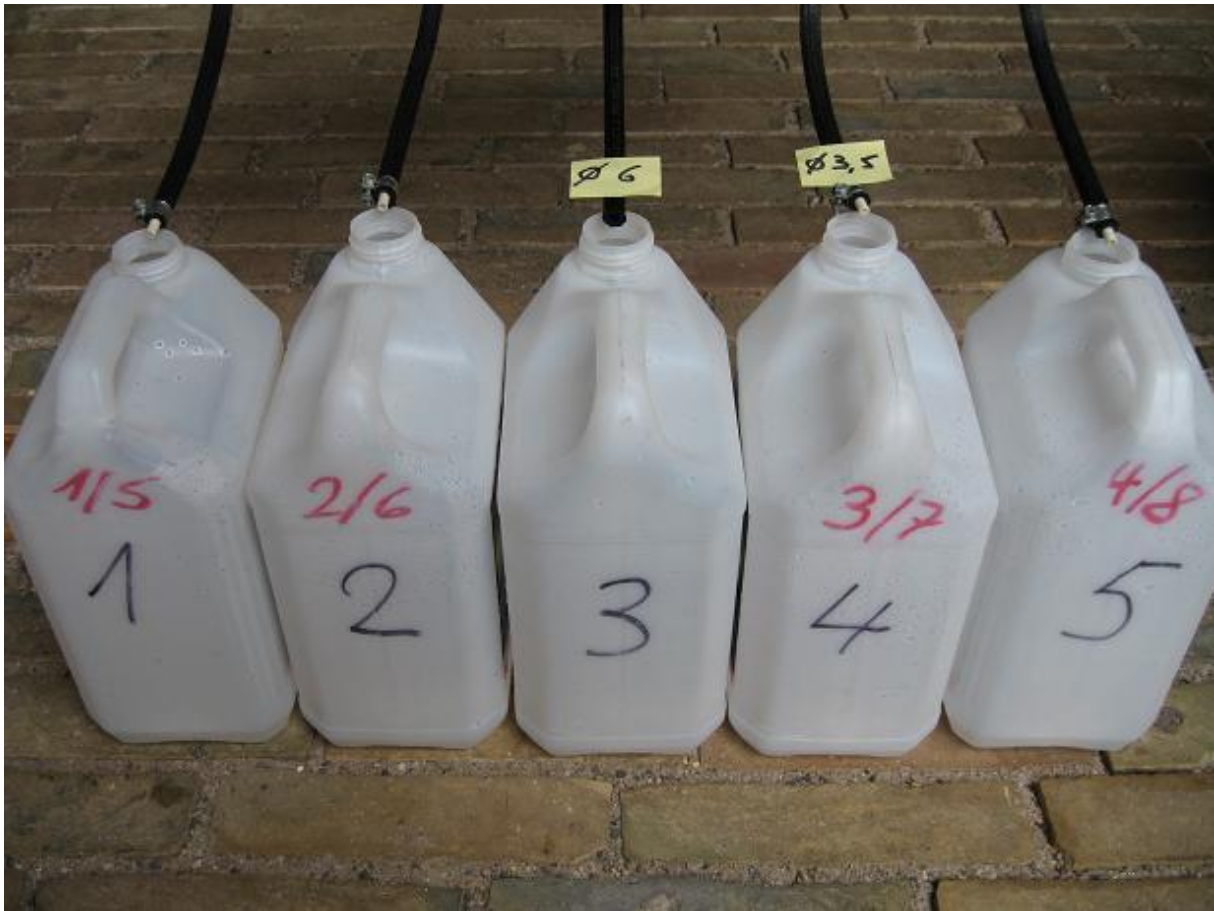
Numbered cans of 5 liters allow to collect and quantify the fluid arriving at the bearing seats of the crankshaft through a hole from 3.5 mm to 6 mm and rods to the cylinder head (to try to reproduce the constraints of the missing channels):

- n ° 1 to the connecting rod bearings 1/5
- n ° 2 to the connecting rod bearings 2/6
- n ° 3 to the cylinder head
- n ° 4 to the levels of connecting rod 3/7
- n ° 5 to the connecting rod bearings 4/8

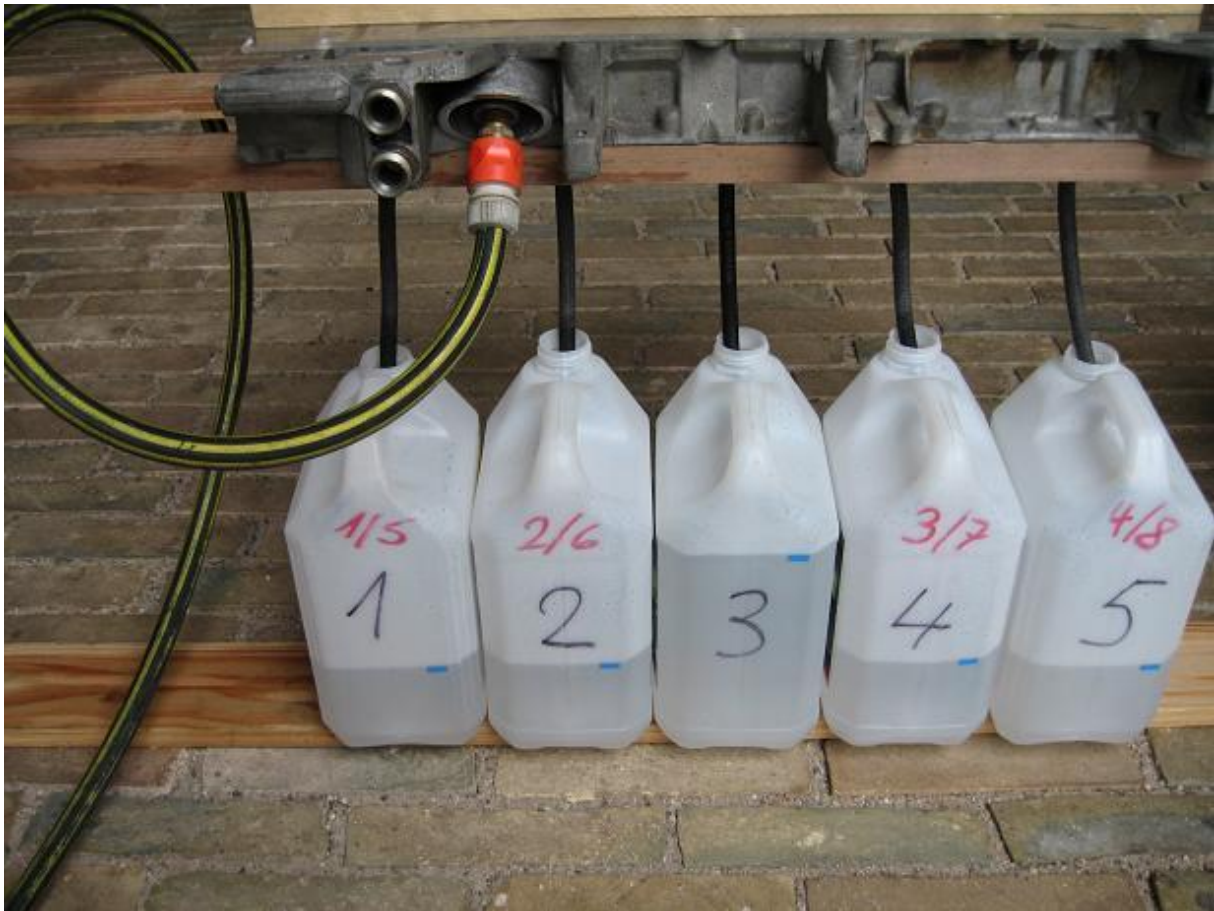
Here are the results (after about 30 seconds), when water not aerated password in these ducts. 4 Cans (No. 1, no. 2, no. 4 and no. 5) receiving the liquid towards the levels of connecting rod, are almost all the same volume.

The No. 3 receiving significantly more liquid, feeds the passenger side cylinder head.

These results appear consistent and correspond to the sizes of ducts. Several successive trials gave similar results.

Blue guides will help later, a direct comparison.

benchmark... - blue.... -Black-Red  
... . . . (without air)... (little air)... (more air)  
n° 5 -.... 2.0 liter.... 2.0 liter.... 2.0 liter  
n° 4 -.... 2.1 liter.... 1.7 liter.... 1.3 liter  
n° 3 -.... 4.7 liter.... 3.2 liter.... 1.8 liter  
n° 2 -.... 2.1 liter.... 1.4 liter.... 0.7 liter  
n° 1 -.... 2.0 liter.... 1.9 liter.... 1.8 liter

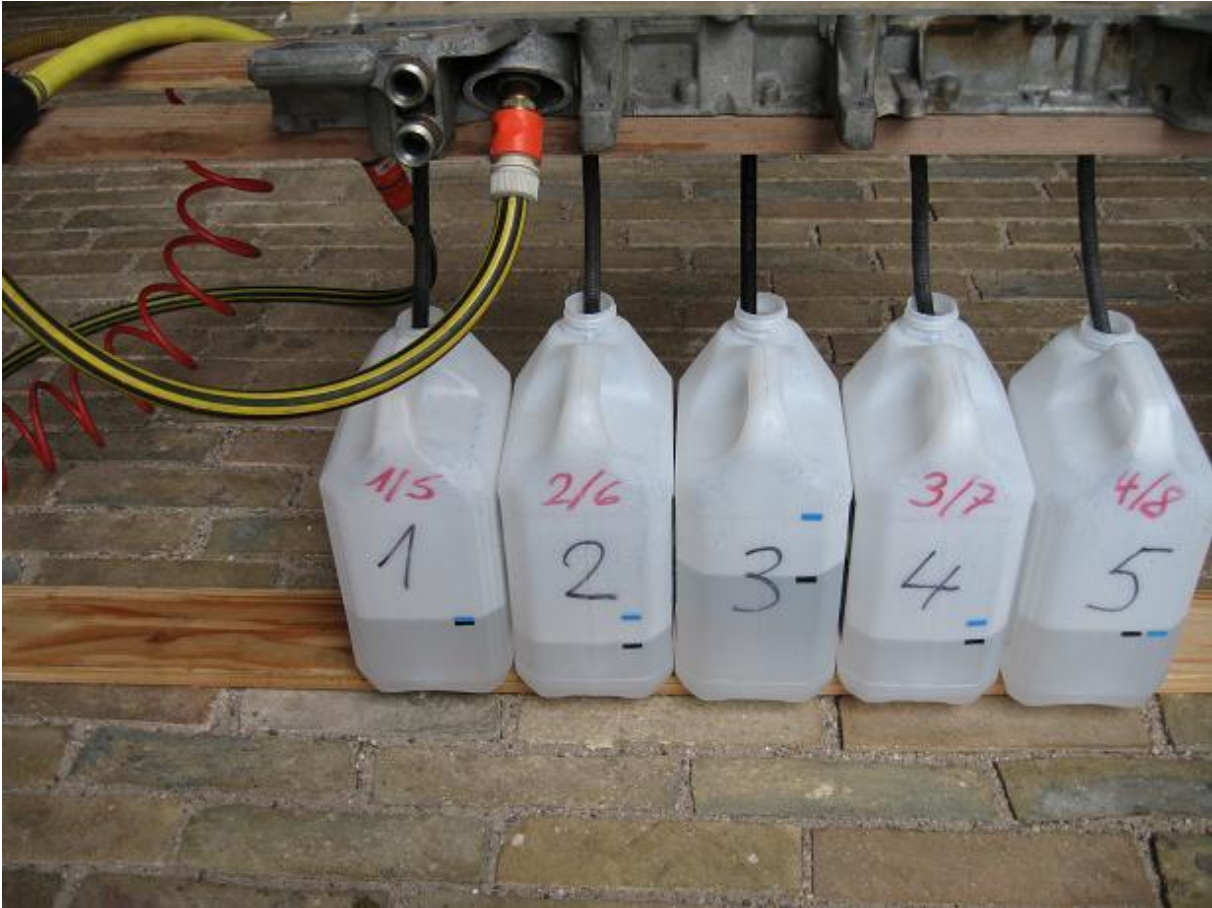
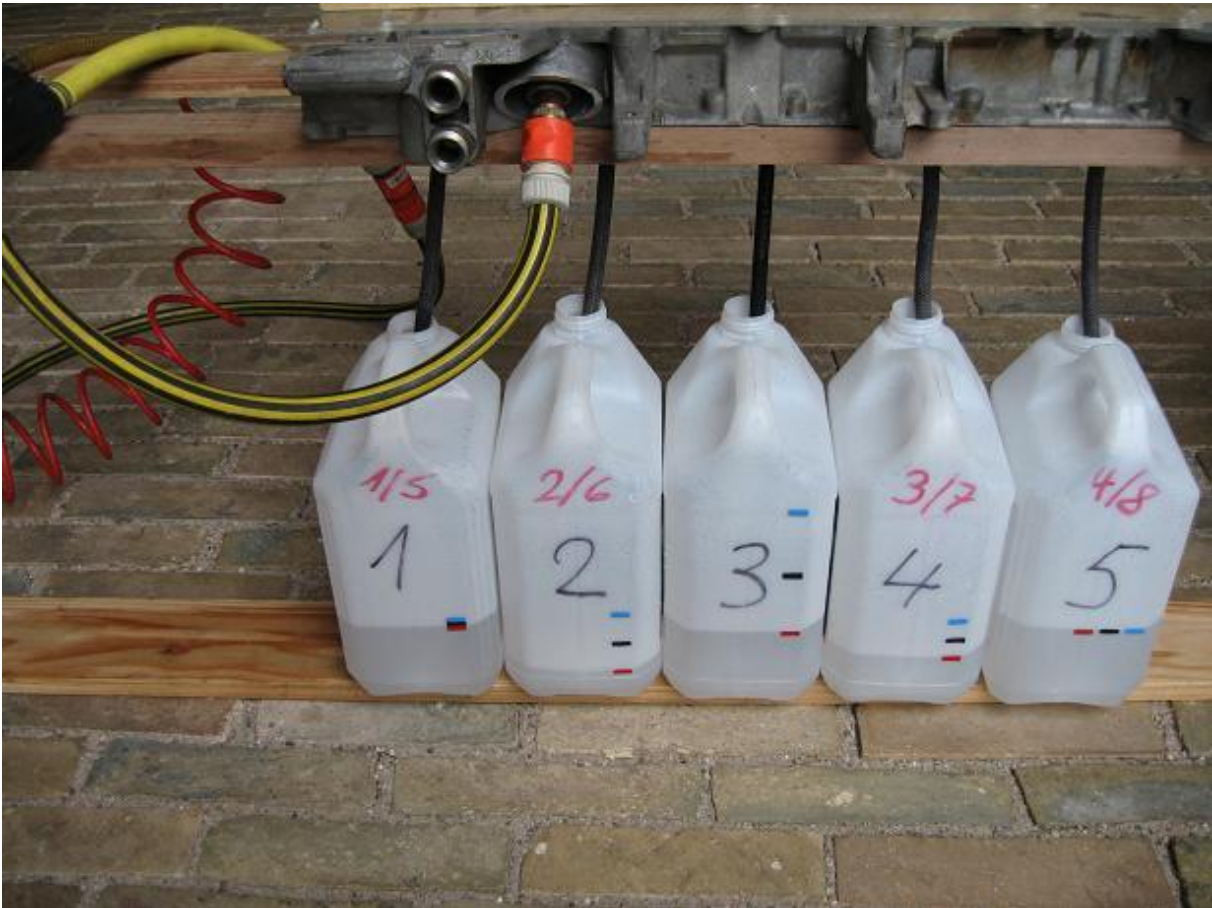
By adding air to aerate the liquid, the distribution is clearly different. First with a bit of corresponding to the black markers and then air with more than air corresponding to the Red markers.

As could be in doubt, it is actually the exit No. 2 (towards levels of connecting rod 2/6) which is the most penalized, receiving much air or aerated liquid.

Exit No. 3 which has more flow, also receives many air or aerated liquid. This output feeds the elements in the cylinder head which appear much less sensitive.

The exit No. 4 also receives lots of air but is almost two times less penalized than the exit No. 2.

Exit No. 1 receives significantly less air than the exits No. 2, no. 3 or no. 4.

Exit No. 5 is the only one which gets very little or not at all air (is only when other outputs are saturated air as it receives and more), therefore, this output taken as benchmark to quantify the missing liquid in other outputs.

Multiple successive trials with aeration showed the same type of result, more or less marked by the proportion of air added in the liquid each time.

Here is a part representative and encrypted test corresponding to the pictures:

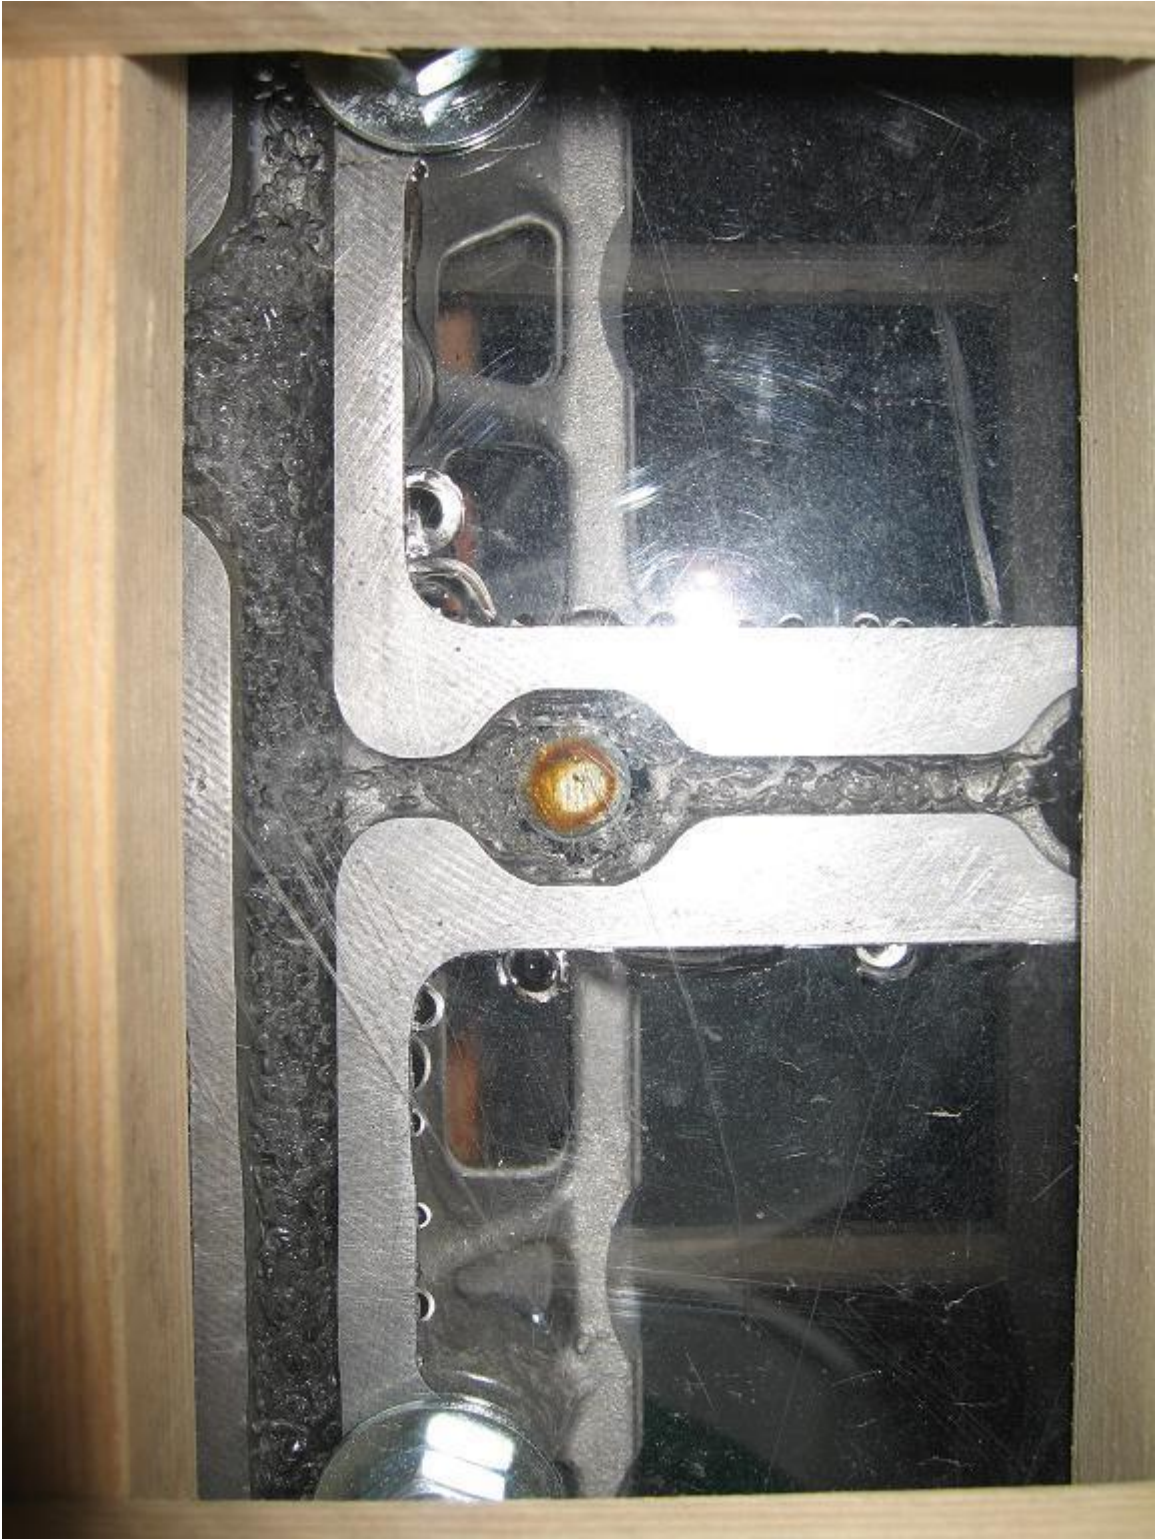
Passage 2/6:

To better see what is happening, here are 5 large vertically aligned plans.

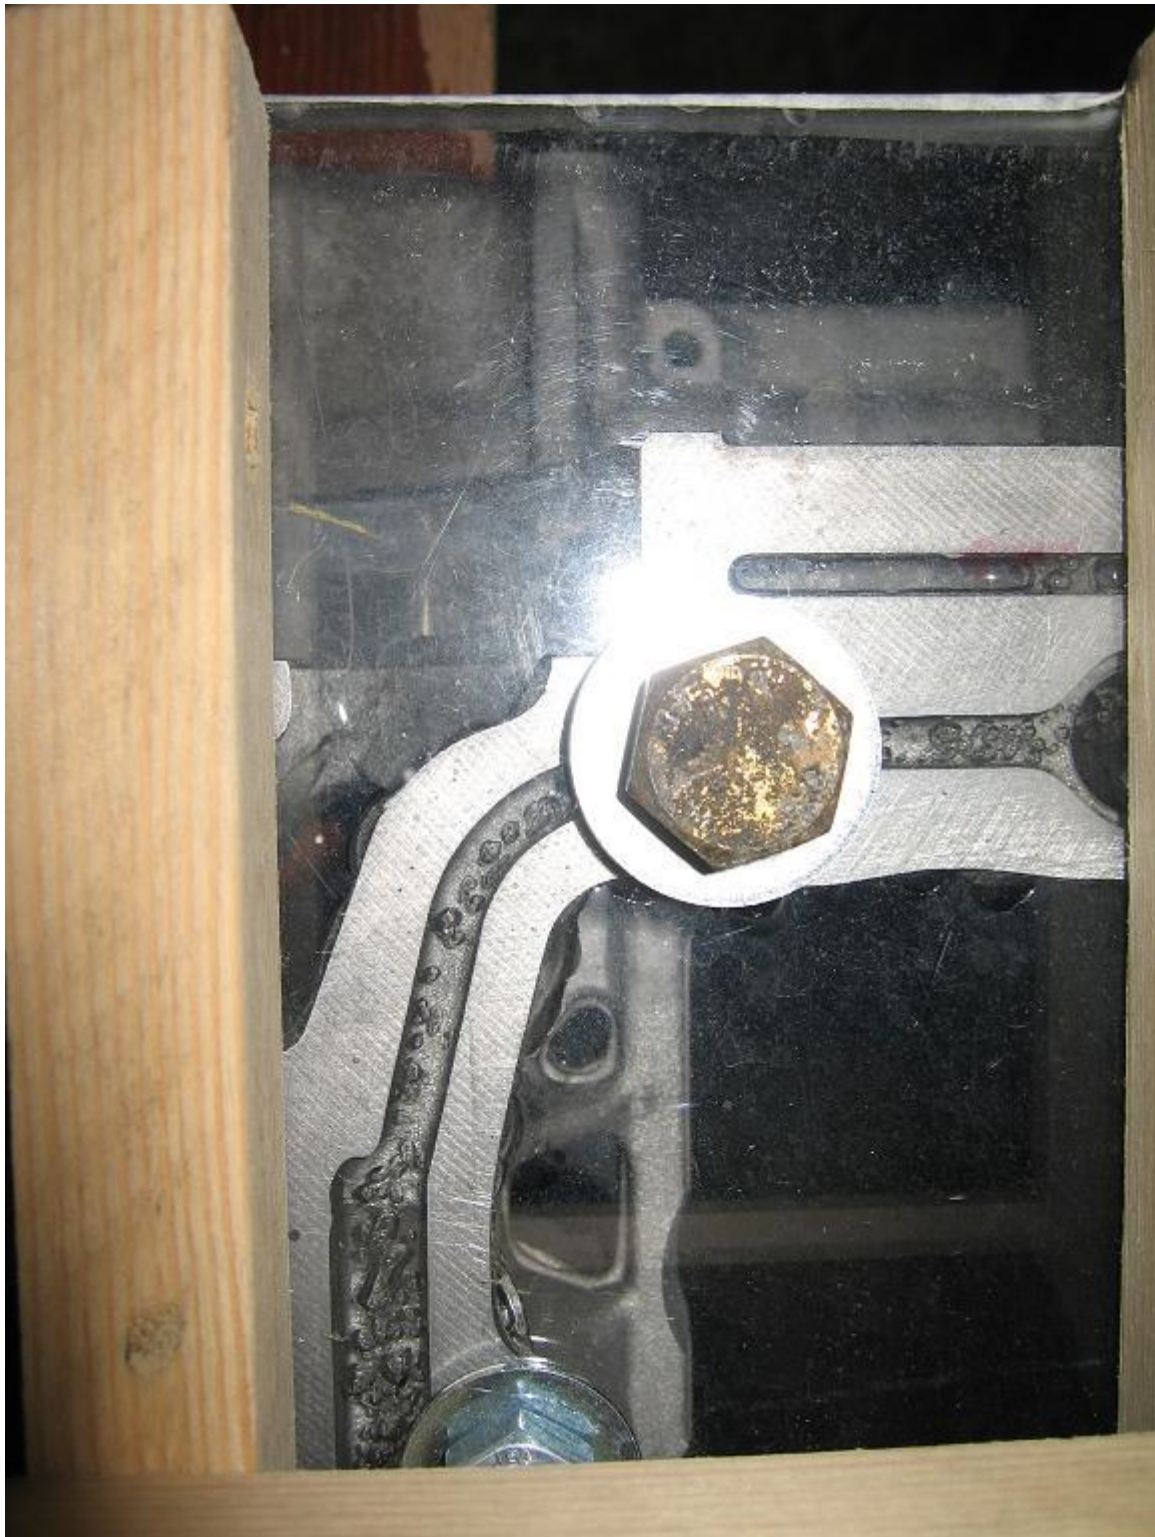
Passage 1/5:

A second version with a little more air.
